PRELIMINARY ENGINEERING REPORT LOWER MONTOYAS WATER QUALITY FEATURE

Prepared by:
Southern Sandoval County Arroyo Flood Control Authority

Date: January 7, 2014

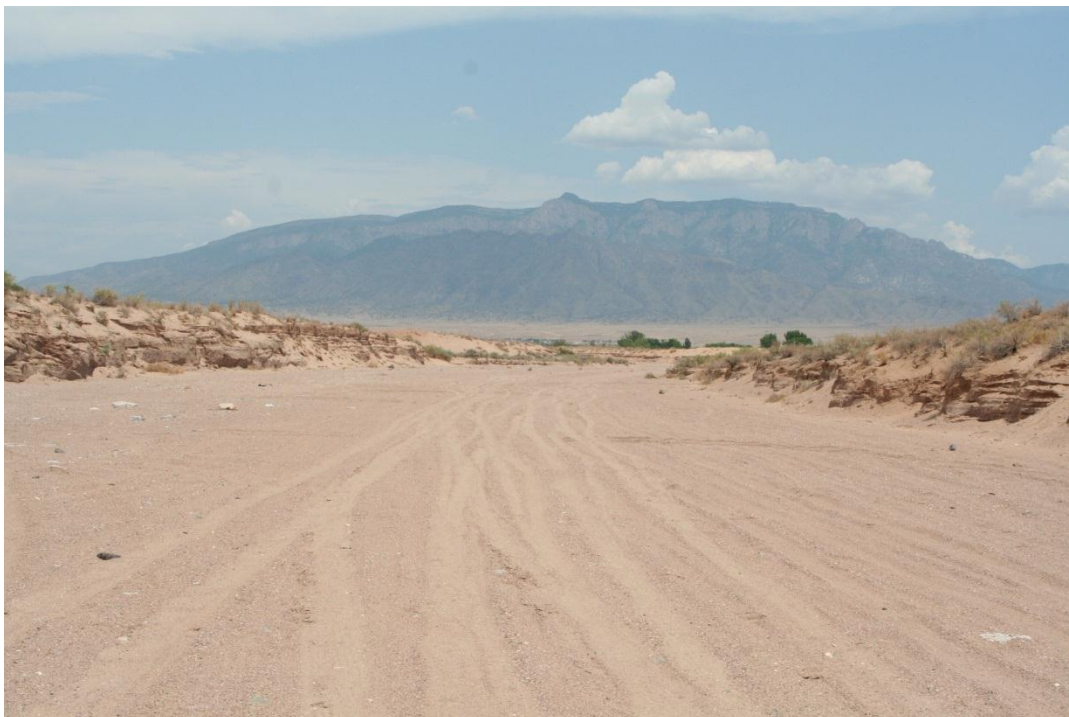
Figure 3: Western project area looking east

The proposed project site is currently a natural arroyo channel. Aside from the inlet to the HJC, there have been no modifications to the arroyo along this reach. Photographs of the project site are located in Figures 3 through 5.

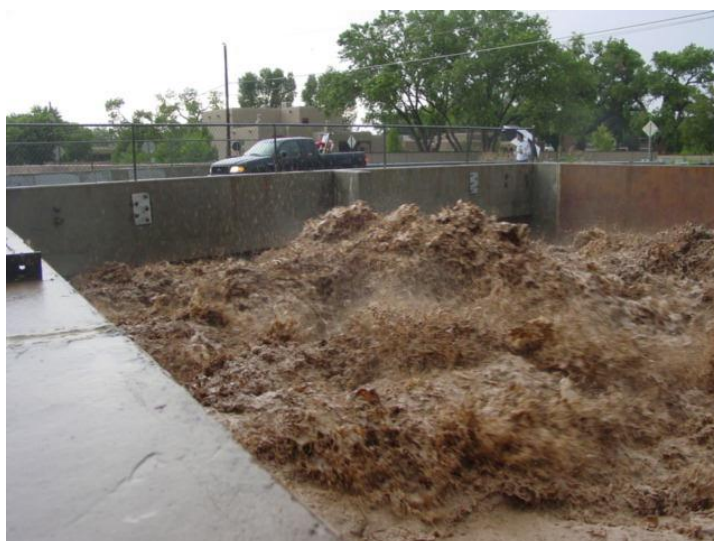
Figure 6: 2006 – Hydraulic jump occurring at Corrales Road bridge

For example, in 2006, a series of large storms created an emergency situation in the Village of Corrales as these storms swept significant amounts of sediment into the hard-lined Harvey Jones Channel, clogging this channel and causing stormwater to overtop the channel and flow into the Village. In order to minimize this flooding, the road had to be closed and the guard barriers had to be removed from the bridge to allow stormwater to flow over the road.

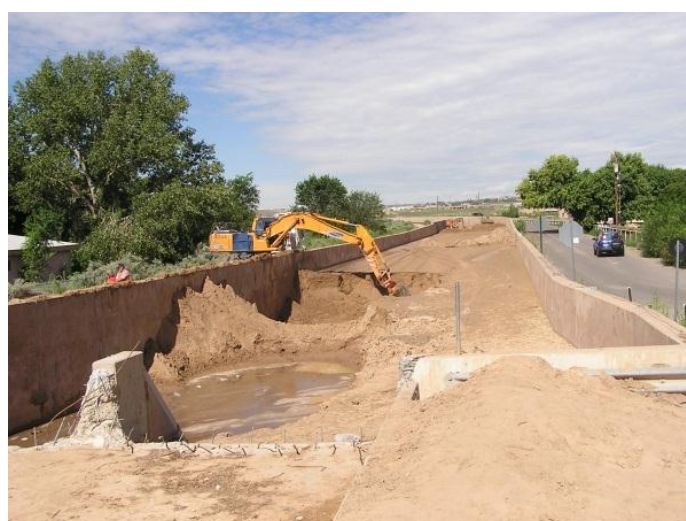
Figure 7: 2006 – Post storm sediment removal at Corrales Road bridge

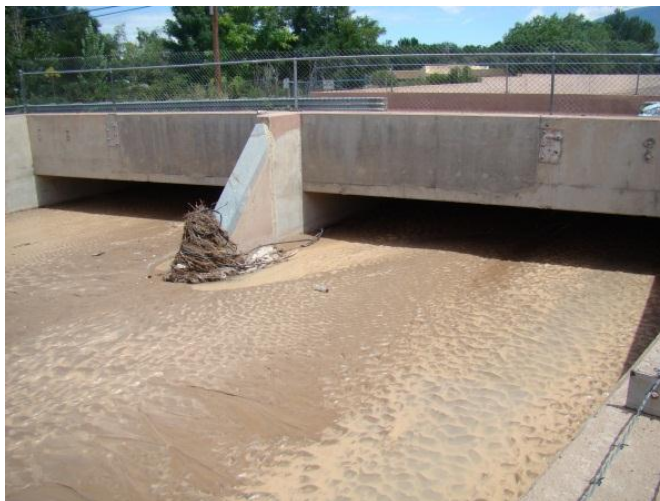
Figure 8: 2010 – Sediment deposition under Corrales Road bridge

In 2010, a single large storm event swept large amounts of sediment into the Channel, once again clogging it. Had there been a subsequent storm that year, it is likely that significant flooding would have occurred in the Village.

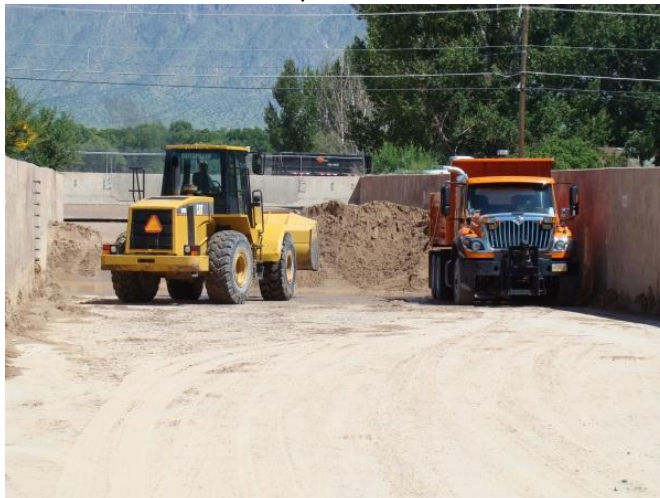
Figure 9: 2010 – Sediment removal upstream of Corrales Road bridge

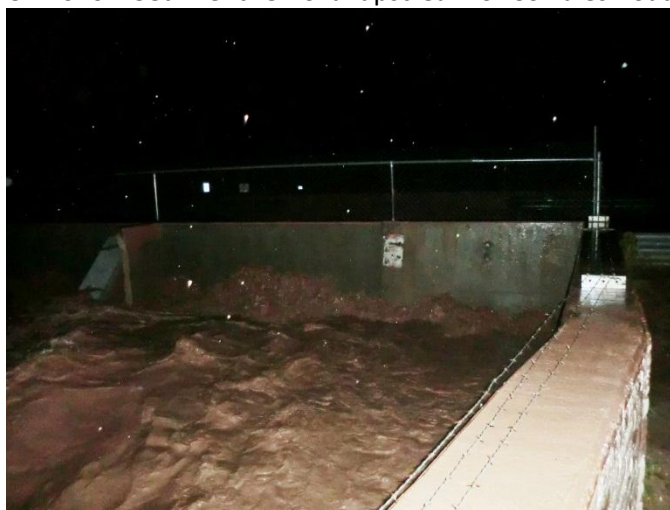
Figure 10: 2013 – Hydraulic Jump into Corrales Road bridge

In 2013, a series of storm events once again swept large amounts of sediment into the channel, plugging the existing concrete box culverts at the NM448/Harvey Jones Channel crossing. Further rainfall after the event occurred could have created a flooding situation in the Village of Corrales.

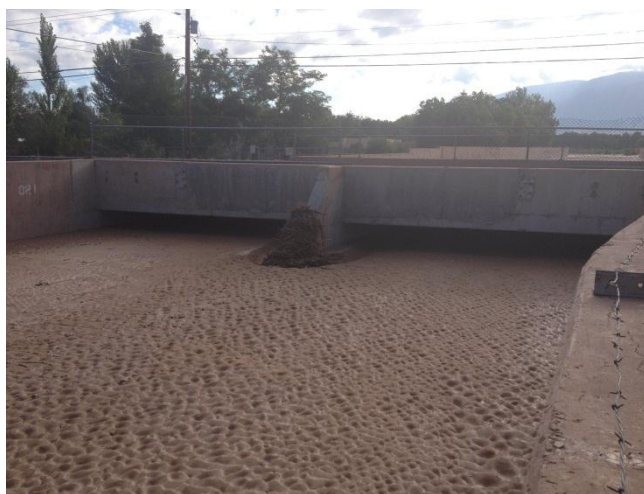
Figure 11: 2013 - Sediment deposition under Corrales Road bridge
