## Quantifying Transmission Losses in a New Mexico Ephemeral Stream – A Losing Proposition

Gerhard Schoener

Watershed Scientist, Southern Sandoval County Arroyo Flood Control Authority (SSCAFCA)  
1041 Commercial Dr. SE, Rio Rancho, NM 87124

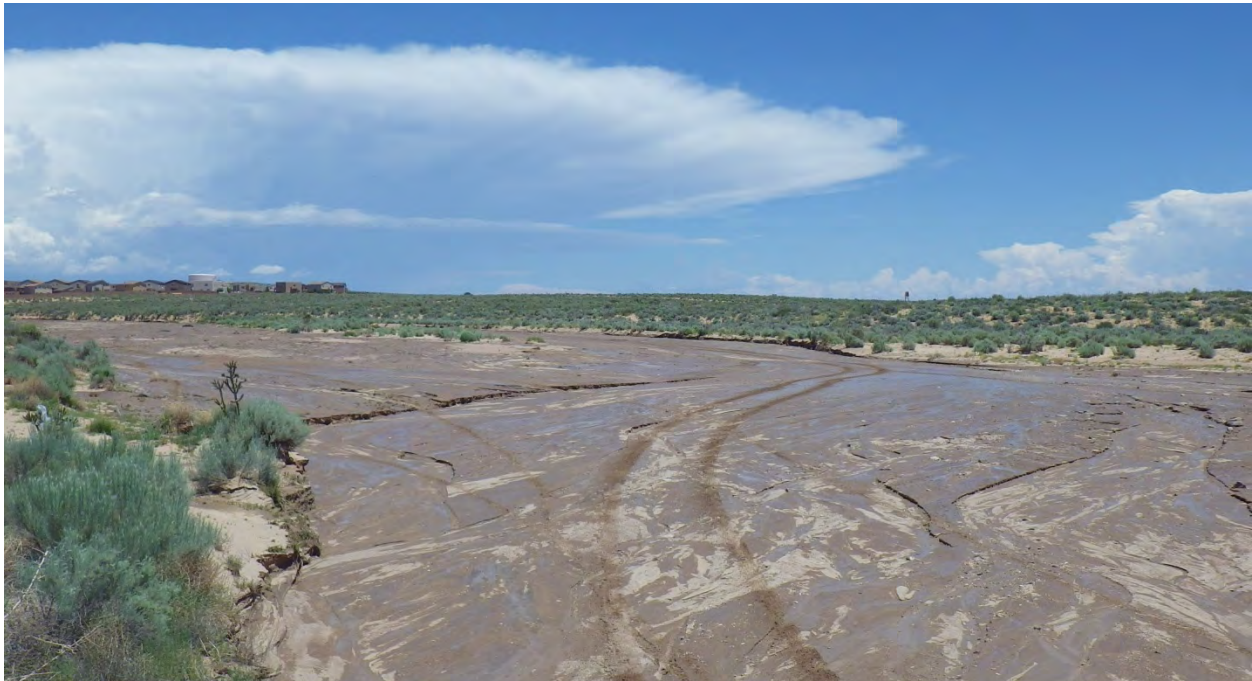
**Fig. 1. Image of the Montoyas Arroyo after a storm; at this location, the arroyo is approximately 40 meters wide (image by author).**

This study examines the 13 kilometer long main stem of the arroyo upstream of the concrete channel. The arroyo bottom is composed of alluvial sediments dominated by sand. Arroyo cross-sections are characterized by wide, very flat bottoms, and often incised, vertical banks. Arroyo bottom widths range from 25 to 90 meters, with an average width of approximately 45 meters (Fig. 1).

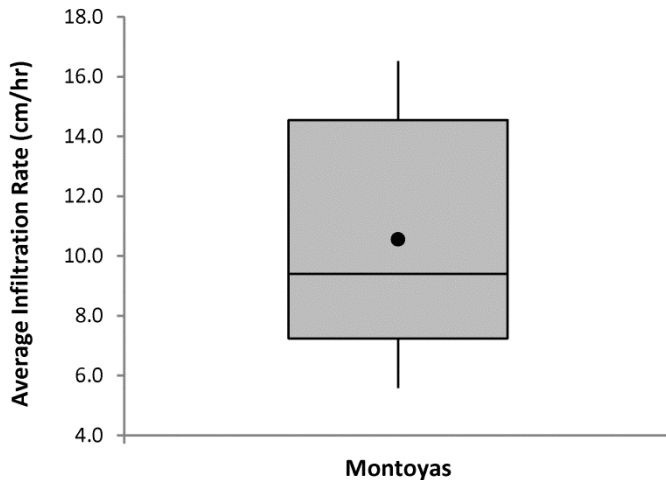
**Fig. 3. Box and whisker plot summarizing infiltration test results from 22 test sites along the Montoyas Arroyo.**

Infiltration test results are displayed as blue bars in Fig. 2. Although arroyo bottom sediments were fairly uniform and consistently low in fines, infiltration rates varied considerably from 3.0 centimeters per hour (cm/hr) up to 19.6 cm/hr, with a median infiltration rate of 9.4 cm/hr. A box and whisker plot of test results can be seen in Fig. 3.

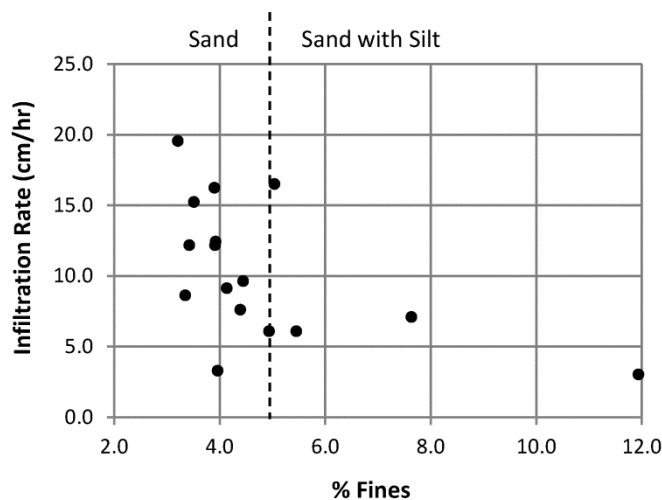
**Fig. 4. Scatter plot comparing measured infiltration rates and % fines from soil samples at sixteen sites in the Montoyas Arroyo.**

Grab samples of arroyo bottom sediments at sixteen infiltration test sites were subjected to particle size analysis in accordance with ASTM Standard D422 (2007). Thirteen samples were classified as sands with trace amount of fines (< 5 percent); three samples were found to be sands with silt (5-12 percent fines). No strong correlation between particle size characteristics and measured infiltration rates at the corresponding 16 test sites could be established (see Fig. 4).

The three test sites with the highest content of fines consistently resulted in low infiltration rates. Sites with soils low in fines (less than five percent), however, showed no correlation between measured infiltration and percent fine material. Since most of the arroyo bottom sediments fall into the sand category, the percentage of fines in a soil sample is not a good predictor for expected infiltration rates at any given site. Other soil parameters based on the particle size analysis ( $D_{10}$ ,  $D_{50}$ ,  $C_u$ ,  $C_c$ ) showed no correlation to measured infiltration rates.

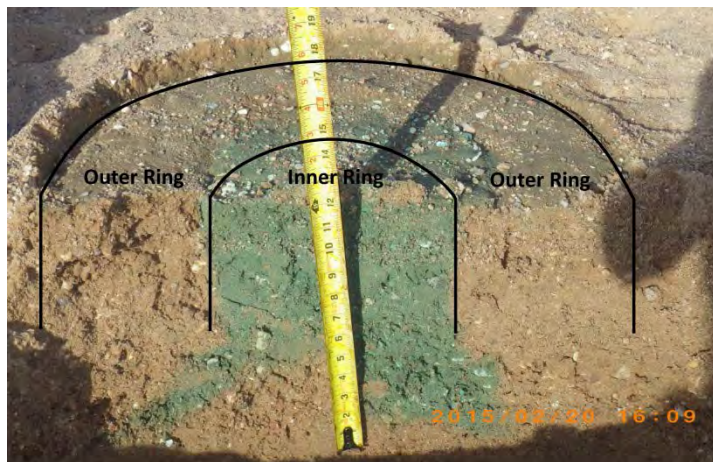
**Fig. 5.** Dye added to the inner ring of a double ring infiltrometer reveals the extent and direction of flow after steel rings have been removed (scale one the tape measure in inches, 1 inch = 2.54 centimeters) (image by author).

During some of the infiltration tests, a blue food-grade dye was added to the water in the inner ring. After completion of the 30 minute test, the steel rings were removed, and a trench was excavated through the center of the test area (see Fig. 5). The depth to which the inner and outer ring penetrated the ground is indicated with black lines in Fig. 5. The dye stained portion of the soil profile reveals that once the wetting front reached the lower end of the inner ring, water started moving laterally. The double ring infiltrometer test therefore likely overestimates actual infiltration rates in the arroyo during flow conditions.

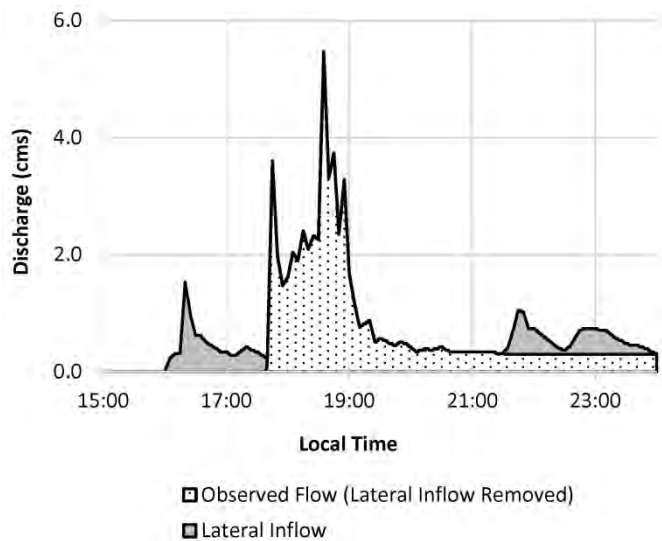
**Fig. 8. Measured hydrograph at gauging station 2 for the storm of July 7, 2015; the portion of the hydrograph caused by lateral inflow is indicated in gray.**

Most of the runoff from the July 7 storm originated upstream of gauging station one. However, some lateral inflow caused by precipitation lower in the watershed entered the arroyo between gauging stations one and two. Lateral inflow was simulated in HEC-HMS (USACE, 2015) based on rainfall measurements from ten tipping-bucket recording rain gauges (SSCAFCA, unpublished data). Lateral inflow was subsequently removed from the measured flow hydrograph at gauging station 2 (see Fig. 8). The total volume of lateral inflow between stations 1 and 2 was estimated at 6,000 cubic meters, with a peak discharge of 1.5 cms. Lateral inflow (see Fig. 8, gray area) did not coincide with the main portion of the hydrograph for gauging station 1 (Fig. 8, dotted area). Not accounting for lateral inflow, runoff volume between stations 1 and 3 decreased by approximately 80 percent.

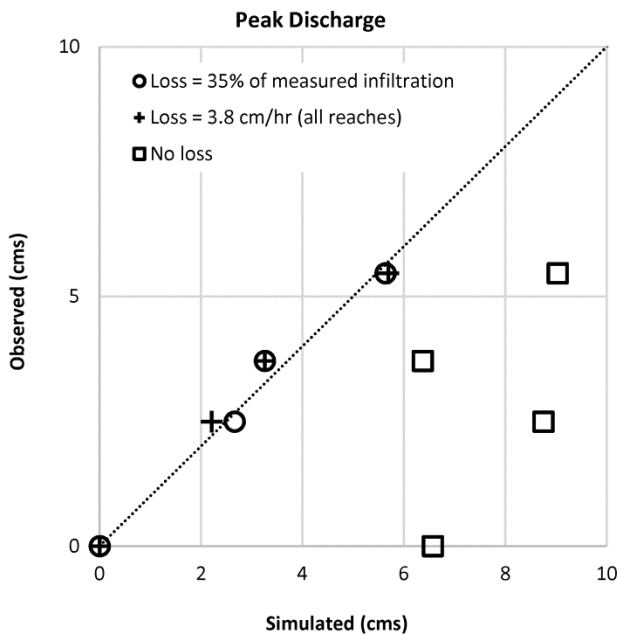
**Fig. 9. Comparison of simulated and measured peak discharges based on three transmission loss scenarios.**

Fig. 9 compares simulated and observed peak discharges at stations 2 and 3 for the storms of June 16 and July 7. Data points to the right of the line of agreement (dotted line) indicate that the model over-predicted measured data.

Points that fall on the line indicate agreement between the model and measured flows. Not surprisingly, model peak flows were higher than observed data when transmission losses were ignored (Fig. 9, squares). Using 35 percent of measured infiltration rates (circles), and using a constant loss rate of 3.8 cm/hr for each reach (crosses) both yielded model results that were close to measured data (points fall close to the line of agreement).

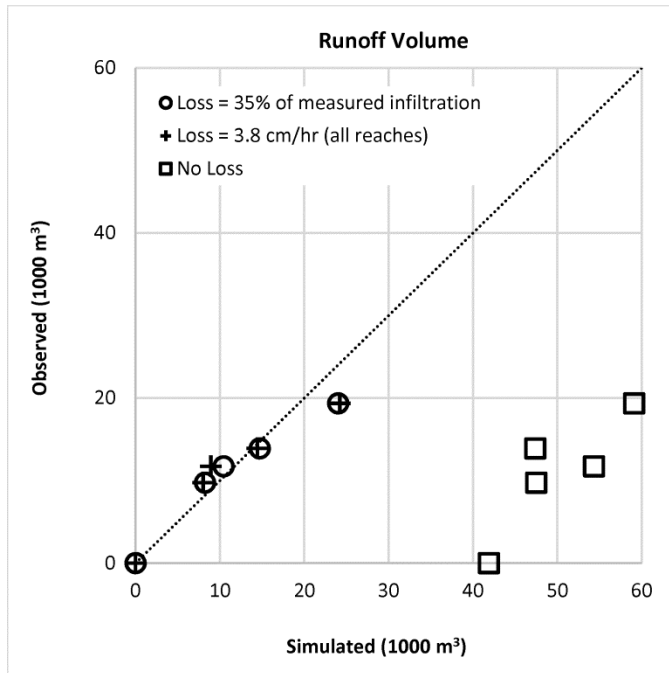
**Fig. 10. Comparison of simulated and measured runoff volumes based on three transmission loss scenarios.**

Fig. 10 compares simulated and observed runoff volumes at stations 2 and 3 for both storms, as well as volumes at the temporary pond for the June 16 storm. Again, model results overestimated runoff volumes when transmission losses were ignored (Fig. 10, squares). Using 35 percent of measured infiltration rates (circles), and using a constant loss rate of 3.8 cm/hr for each reach (crosses) both resulted in simulated volumes that closely matched measured data.

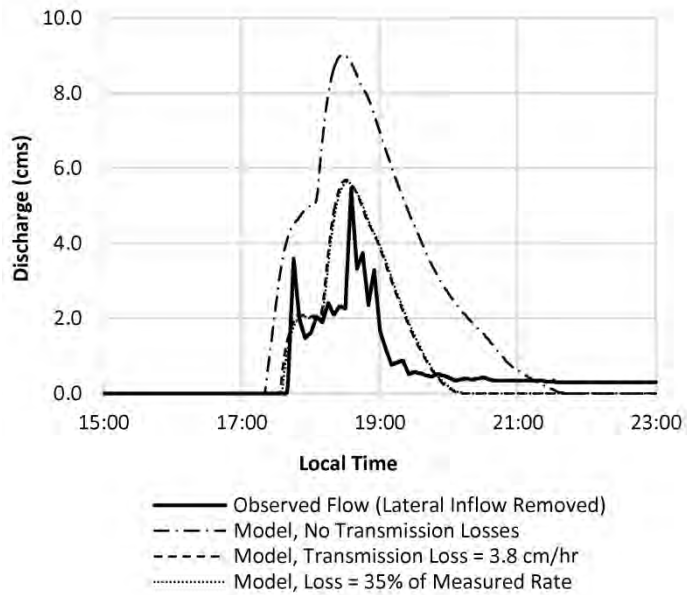
**Fig. 12. Comparison of measured (solid) and simulated hydrographs (dotted, dashed, dash-dotted) at gauging station 2 for the storm of July 7, 2015.**

Fig. 12 displays the measured hydrograph (solid, lateral inflow removed) at gauging station 2 for the July 7 storm compared to the model hydrograph with no transmission losses (dash-dotted), with uniform transmission losses of 3.8 cm/hr for all reaches (dashed), and losses equal to 35 percent of the measured rate for each reach (dotted).

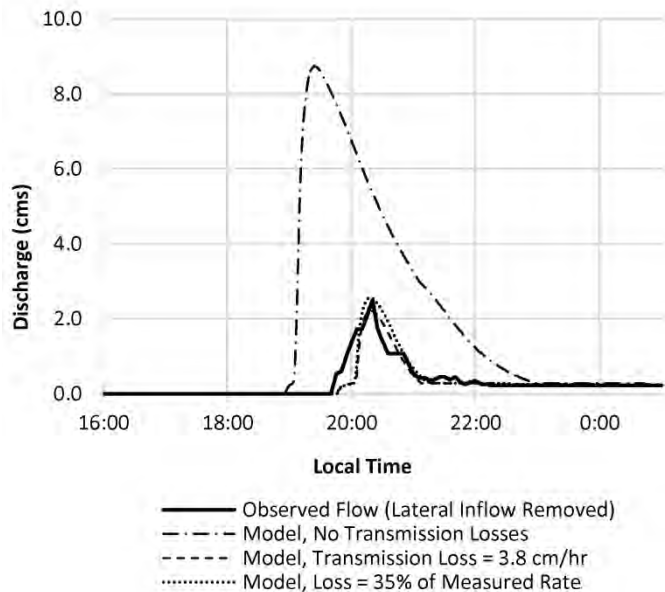
**Fig. 13. Comparison of measured (solid) and simulated hydrographs (dotted, dashed) at gauging station 3 for the storm of July 7, 2015.**

Fig. 13 shows the same comparison at gauging station 3. The example illustrates that the difference between modeled and observed flows becomes larger going downstream when transmission losses are ignored. Both scenarios of accounting for transmission losses adequately replicated measured hydrographs, with exception of the receding limb of the hydrograph at station 2.
